Project Name	Project Number	Project Date
N1427-Northolt-High-School	N1427	23/05/2022

Section Inspection

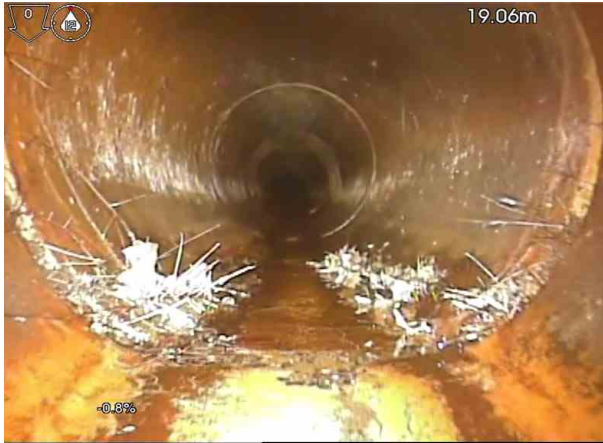
1, 00:01:32, 19.00 m

Roots, mass at joint, 5% cross-sectional area loss

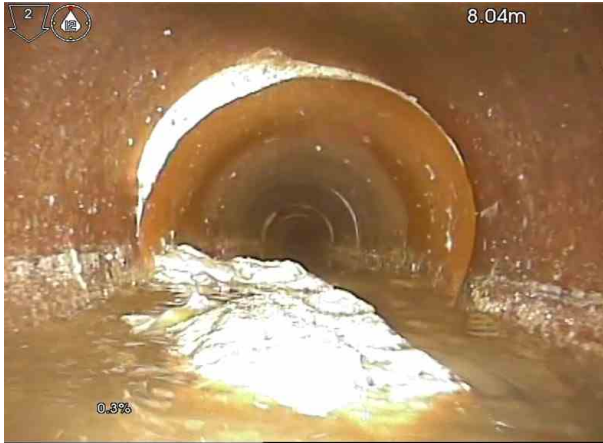
1, 00:02:00, 8.00 m

Other obstacles in invert from 4 o'clock to 8 o'clock, 20% cross-sectional area loss, Possible Rubble

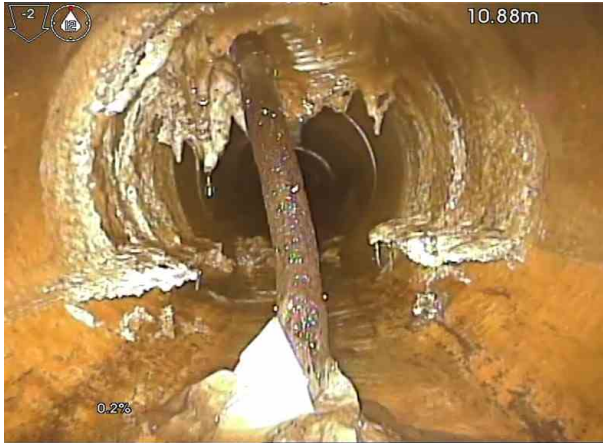
1, 00:00:58, 10.90 m

<table><tr><td></td><td></td><td>0.00</td><td>MH</td><td>Start node, manhole, reference: SW10</td><td></td><td></td></tr><tr><td></td><td></td><td>10.90</td><td>OBC</td><td>Obstacles through connection or junction at 12 o'clock, 5% cross-sectional area loss: Metal Spike</td><td>1</td><td>5</td></tr></table>

Obstacles through connection or junction at 12 o'clock, 5%
cross-sectional area loss, Metal Spike
