Project Name	Project Number	Project Date
N1427-Northolt-High-School	N1427	23/05/2022

Section Inspection

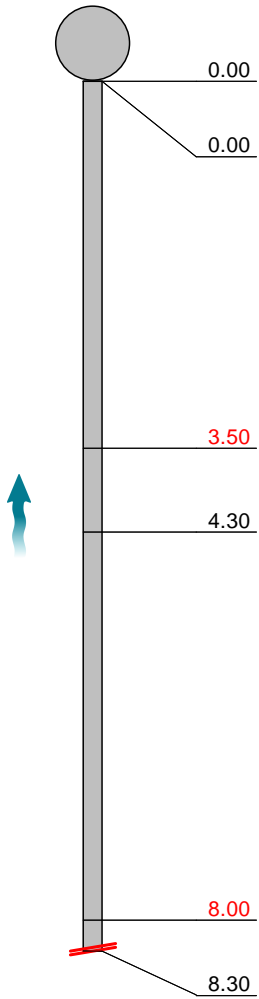
Scale:	1:72	Position [m]	Code	Observation	Photo	Grade			
<div><div><div>Depth: m FW7802</div><div>

</div></div></div>									
		0.00	MH	Start node, manhole, reference: FW7802					
		0.00	WL	Water level, 5% of the vertical dimension					
		3.50	OBX	Other obstacles in invert from 4 o'clock to 8 o'clock, 15% cross-sectional area loss: Unknown Obstruction		5			
		4.30	WL	Water level, 15% of the vertical dimension					
		8.00	OBX	Other obstacles in invert from 4 o'clock to 8 o'clock, 20% cross-sectional area loss: Possible Rubble	1	5			
		8.30	SA	Survey abandoned: Stuck at Obstruction					
STR No. Def	STR Peak	STR Mean	STR Total	STR Grade	SER No. Def	SER Peak	SER Mean	SER Total	SER Grade
0	0.0	0.0	0.0	1.0	2	10.0	2.4	20.0	5.0

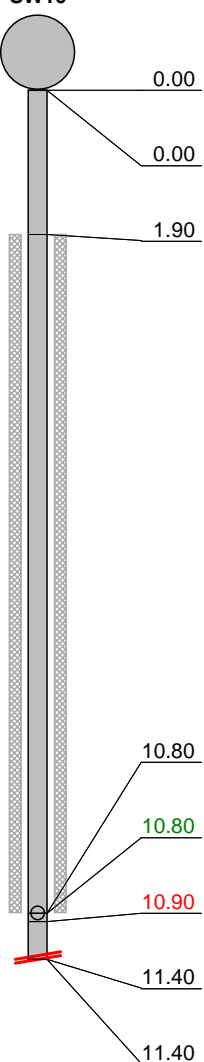
Scale:	1:99	Position [m]	Code	Observation	Photo	Grade																																																								
<div><div><div>Depth: m</div><div>SW10</div>

<table><tr><td></td><td></td><td>0.00</td><td>MH</td><td>Start node, manhole, reference: SW10</td><td></td><td></td></tr></table>
